# Preliminary Accident Report

Version number: 1.1

Date 29 July 2023

**Reference Number:** SAHPA/103/04/04/2023

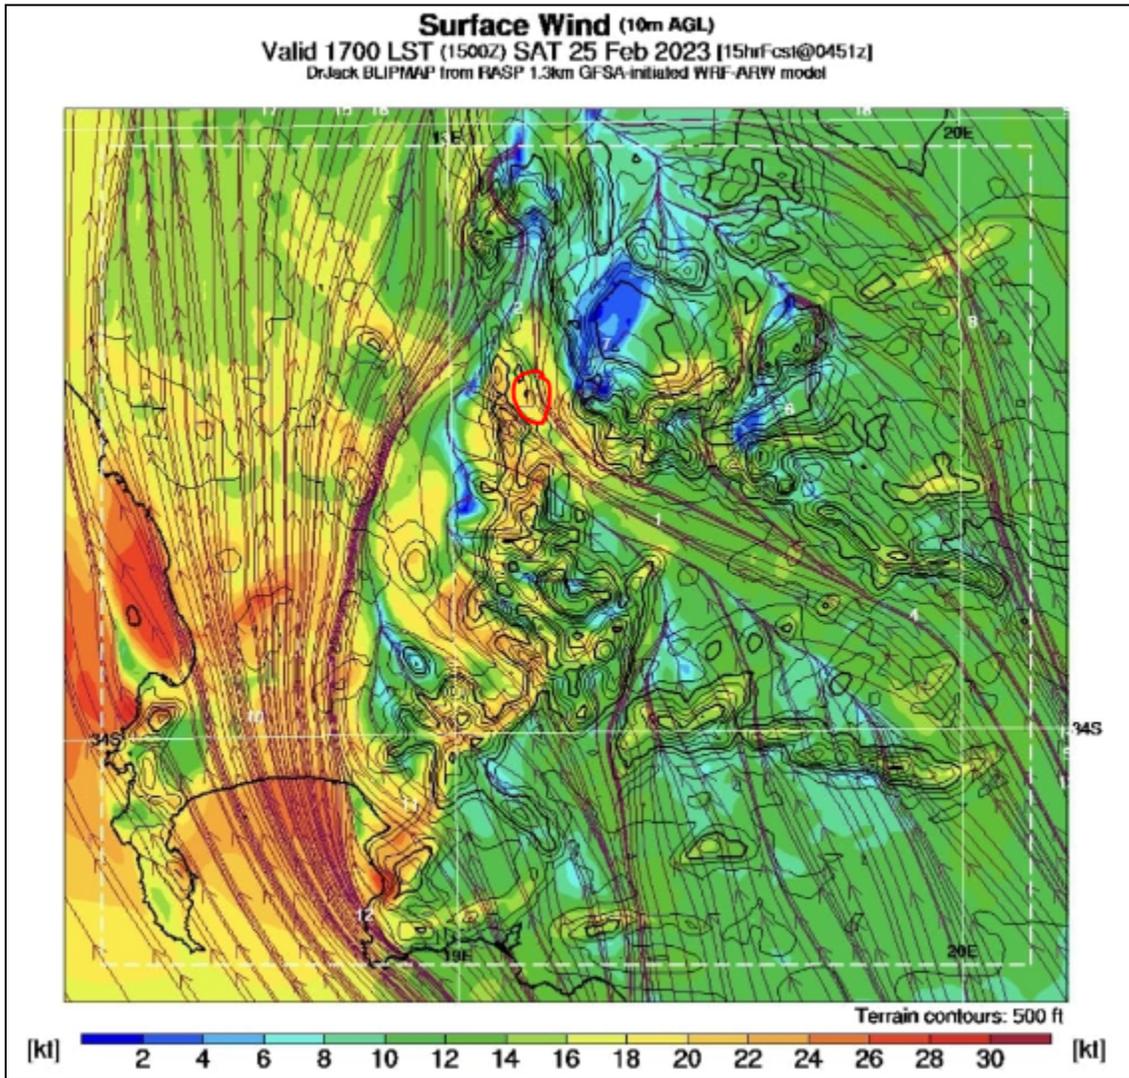
**Figure 9:** RASP 5 pm Surface wind forecast. Map orientation north facing up. The accident location is circled in red.

- 1) Surface wind speed forecast for Worcester (labelled 1 in the RASP diagram) is ~14kts (26kph)
- 2) Surface wind forecast for the accident site (circled in red) is ~ 20kts (37kph)
- 3) A southeast wind flowing through the Worcester valley was forecast to turn into southerly wind direction in the valley where the accident occurred.

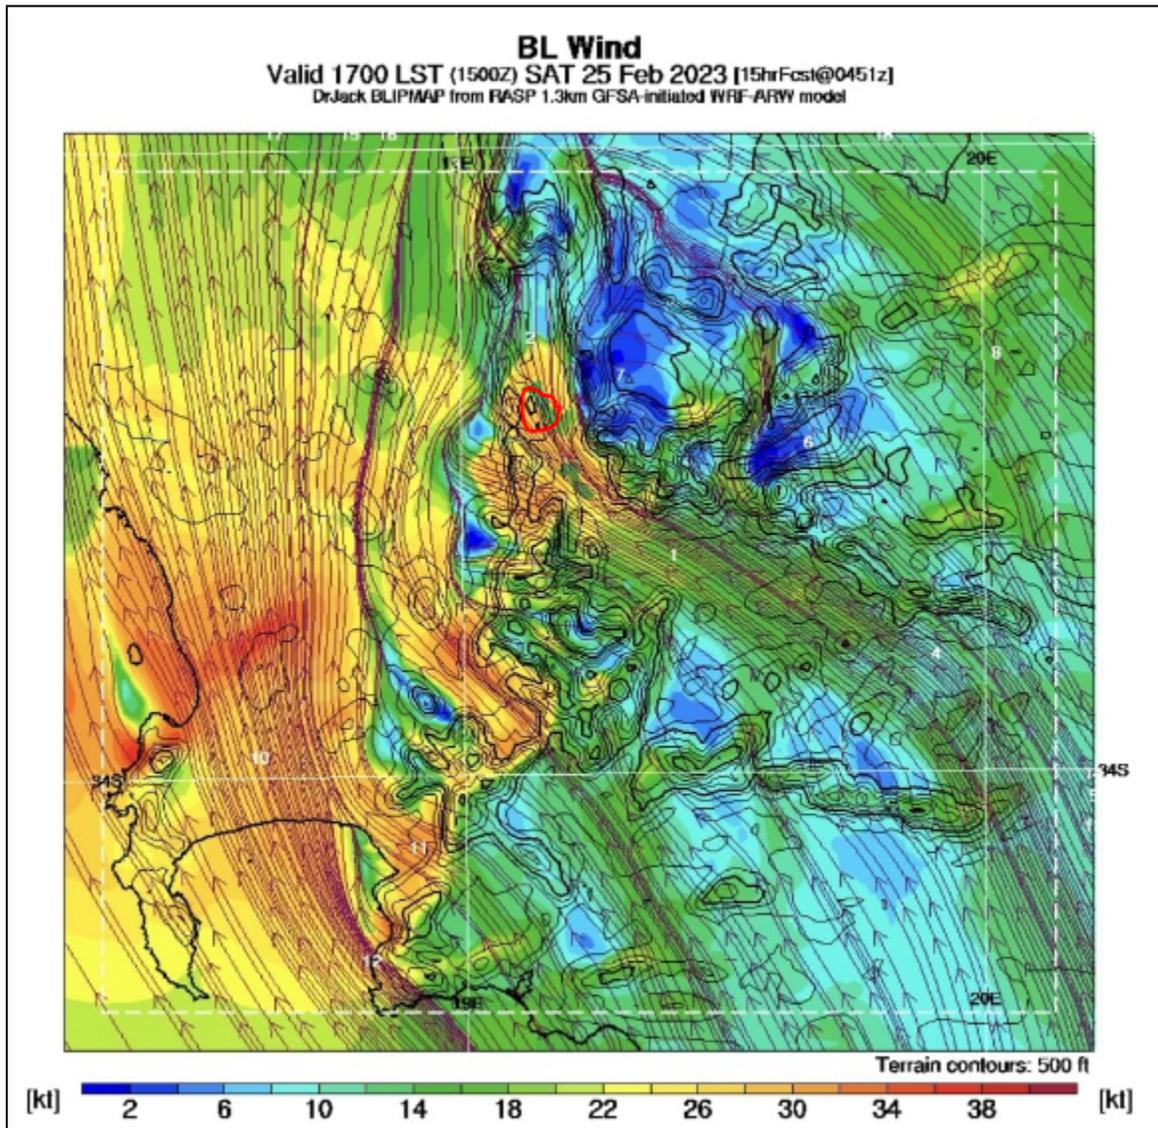
**Figure 10:** RASP 5 pm boundary layer average wind forecast. Map orientation north facing up. The accident location is circled in red.

- 4) The boundary layer is the layer of air in which thermals from the ground level rise up to. The type of paragliding flight used in the case of this accident was that of thermal flying. The forecast average boundary layer wind gives an idea of the average wind speed above ground level and within which this paragliding flight would have taken place.
- 5) Boundary layer average wind speed forecast for Worcester (labelled 1 in the RASP diagram) is ~16kts (30kph)

- 6) Boundary layer average forecast for the accident site (circled in red) is ~ 30kts (56kph)
- 7) A southeast wind flowing through the Worcester valley was forecast to turn into southerly wind direction in the valley where the accident occurred.
- 8) The Boundary Layer average wind speeds are higher than the surface wind speeds, indicating an increase of wind speed with altitude above ground level

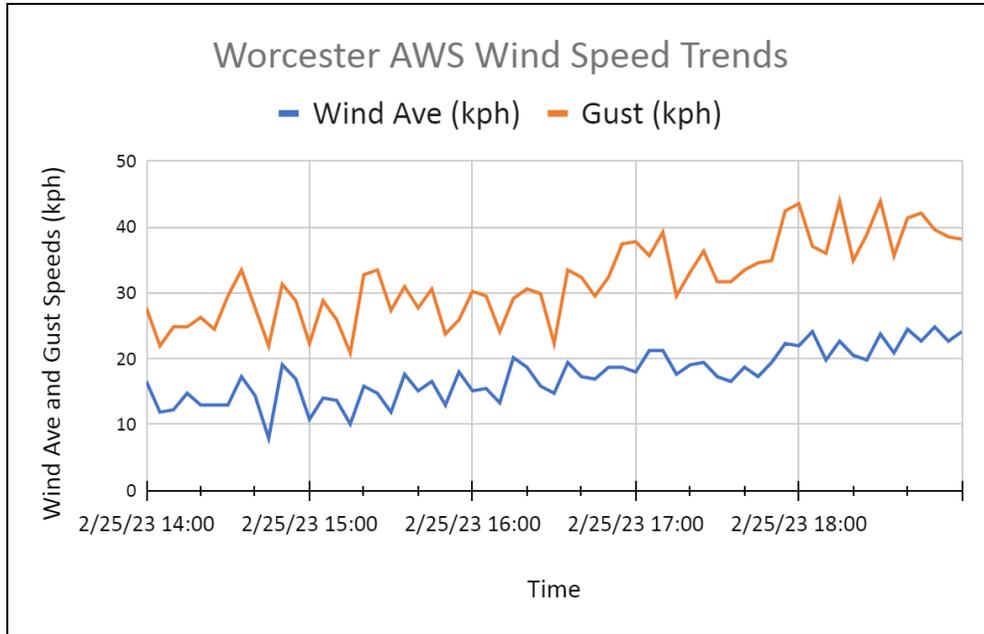
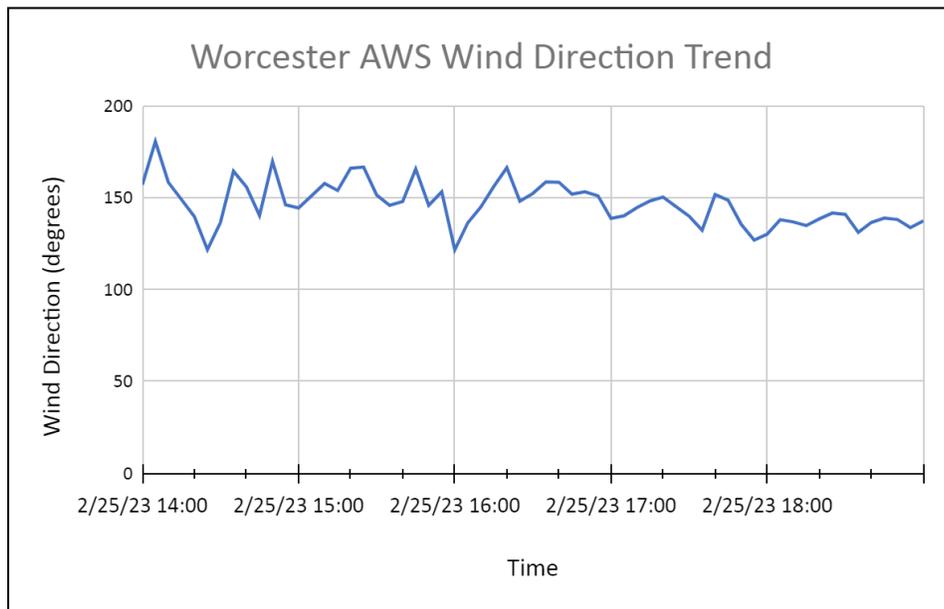
**Figure 12:** Worcester weather station wind speed over time

**Figure 13:** Worcester weather station wind direction over time

- 1) The Worcester AWS readings show an increasing wind speed trend from 2 pm to 7 pm
- 2) The wind direction in Worcester throughout the afternoon was approximately SE (135 degrees ) to SSE (157.5 degrees)

- 3) At 14h35 the average wind speed was 17kph whilst the gust speed was 33kph

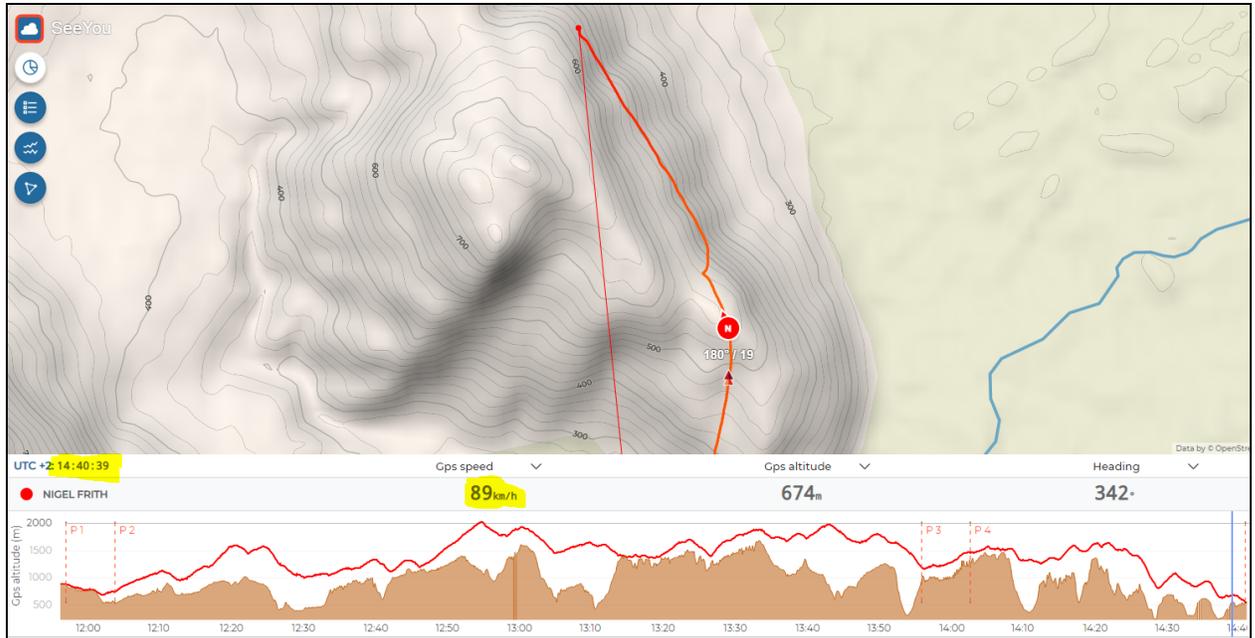
1.10.1.2. 2D View showing the last section of the flight. At 14:40:39 a GPS Speed of 89kph was recorded at 14h40 i.e. two minutes before the accident. It also shows that the pilot flew on NNW heading following the contour of the ridge. **The accident occurred on the downwind side of the ridge if the wind was coming from the south.**

**Figure 17:** Final section of the flight leading to the accident. Map orientation north facing up.

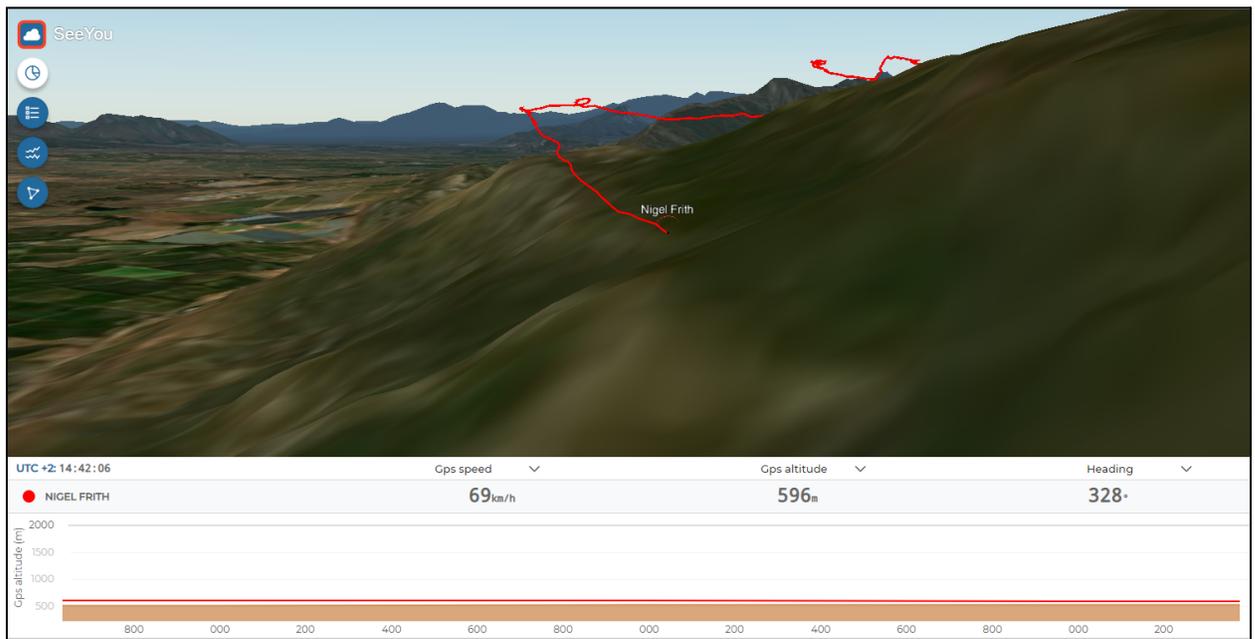
1.10.1.3. 3D View showing the pilot flying along the ridge on which the accident took place. The snapshot is taken at 14:42:06, almost 30 seconds before the accident. The view shows that the pilot arrived at the corner of the ridge and then turned to follow a NNW heading along the contour of the ridge. It can be seen that the pilot was descending as he flew along the ridge.

**Figure 18:** 3D view showing the flight path taken at ~30 seconds prior to the accident

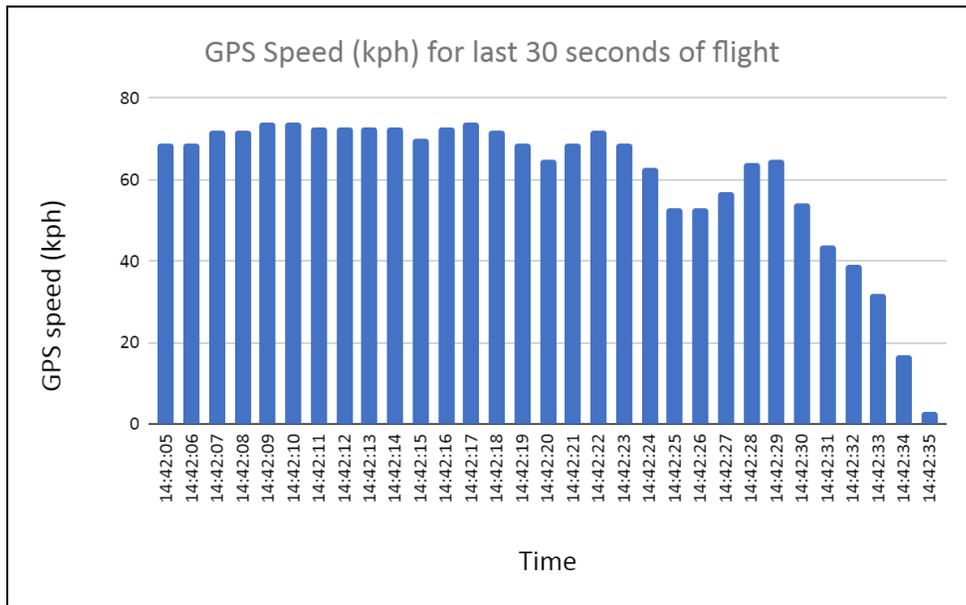
1.10.1.4. Analysis of GPS Speed **for the last 30 seconds of flight. Speeds in excess of 70kph are regularly recorded.** Sharp drop off in speed to point of accident. NB. Each column on the graph represents one second.

**Figure 19:** Tracklog derives GPS speed for the last 30 seconds of flight

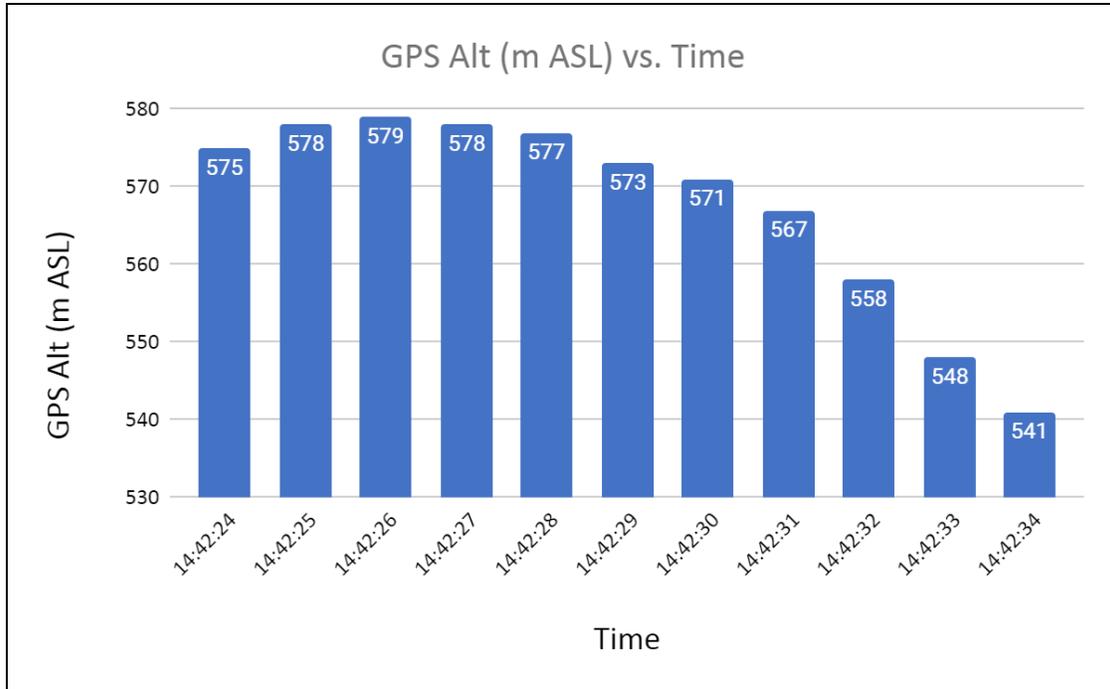
1.10.1.5. Analysis of GPS altitude for the last 10 seconds of flight. The typical descent rate of a paraglider is 1m/s in still air. Paragliding rescue parachutes are tested to withstand landings of 5.5m/s. In the last 3 seconds before coming to a stop, the glider descended from an altitude of 567m to 541m. This equates to a drop of 26m over 3 seconds or an average descent of 8.7m/s. This is a **significantly high descent rate**. It also implies that the **pilot was relatively close to the terrain** when an occurrence caused the rapid loss of height which resulted in the accident.

**Figure 20:** Tracklog derives GPS altitude for the last 10 seconds of flight. Rapid loss of altitude starts from 567m ASL. The accident occurred at 541m ASL.

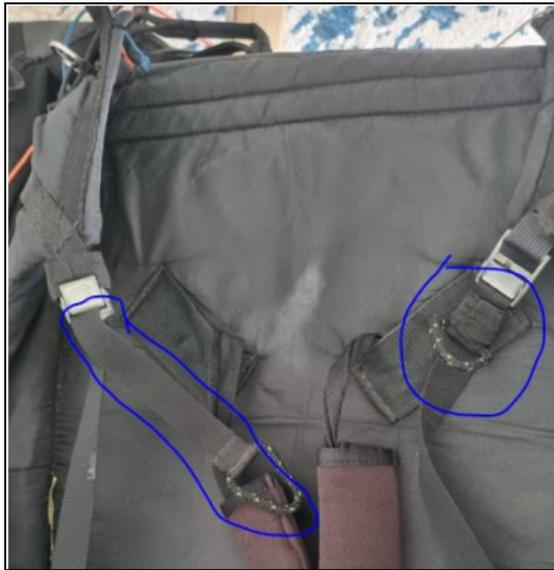
Figure 22: Harness setup showing leg straps asymmetry

1.15.2.1. Harness Inspection: Cleats holding the front of the seat board in place were set up asymmetrically

2.4.1. The pilot's harness was set up asymmetrically - this could have had a negative impact on his control of the craft when he encountered turbulence. However, it should be noted that it is unknown whether the asymmetrical setup was changed during or after the accident.

4.4.1. It is recommended that SAHPA educate its pilots on the basics of equipment maintenance including the dangers of asymmetrical setups.

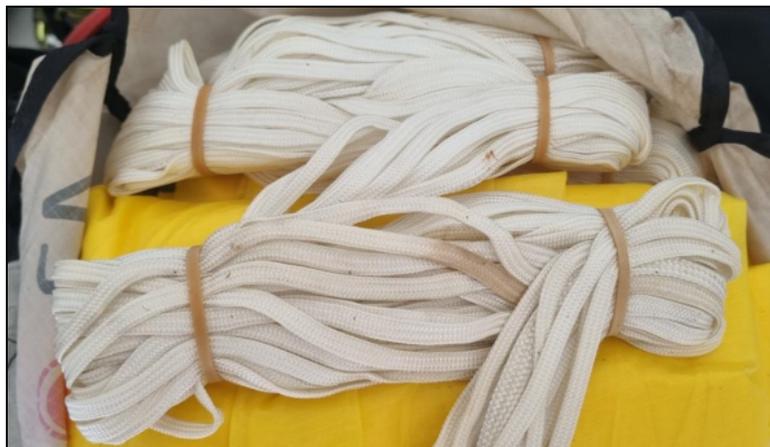
Figure 23: Rescue parachute lines

1.15.2.2.1. Rescue parachute: The Gin One G was found to be in serviceable condition, with relatively fresh elastics holding the lines together:

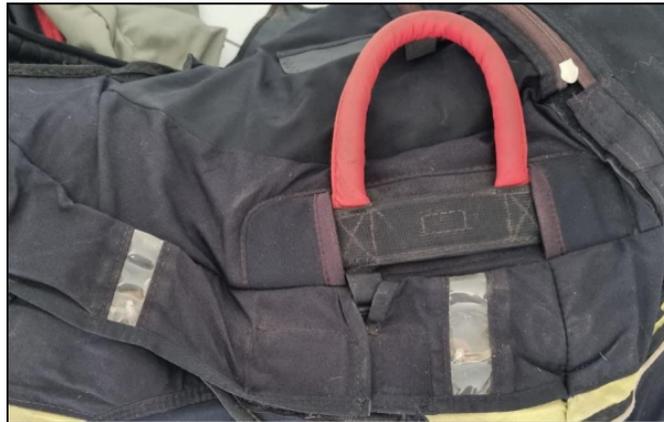
Figure 24: Rescue handle in position

- 1.15.2.2.2. Rescue handle: The Rescue handle pins were found to be in position on the harness, with the Rescue parachute requiring no more than 650g force to extract the Rescue from the container

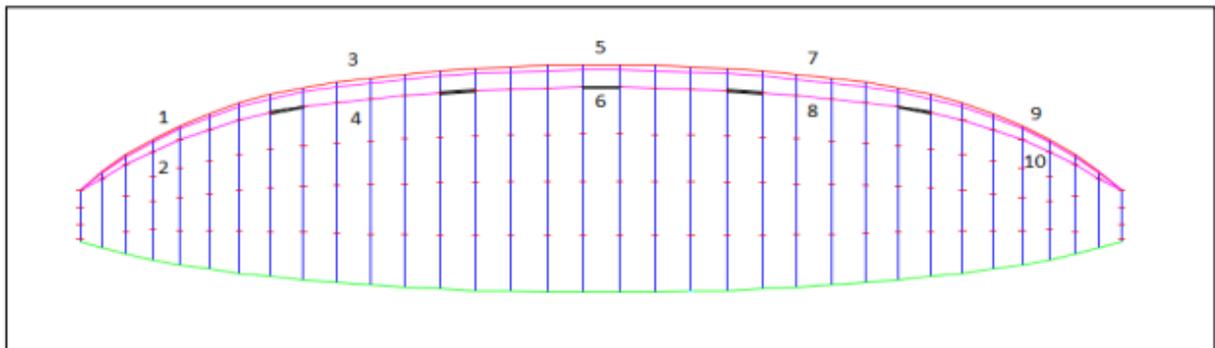
Figure 25: Porosity test locations

- 1.15.2.3.6. Fabric porosity tests: **the top surface fails due to the reading at one of the locations being <19 seconds**. The bottom surface was not measurable, as the air passed through the porosity meter faster than the meter could be set up indicating that the fabric on the bottom surface is completely porous.

<b>1</b>	<b>3</b>	<b>5</b>	<b>7</b>	<b>9</b>	
<b>45.1</b>	<b>27.7</b>	<b>24.8</b>	<b>44.9</b>	<b>17.7</b>	<b>sec</b>
<b>2</b>	<b>4</b>	<b>6</b>	<b>8</b>	<b>10</b>	
<b>0.2</b>	<b>0.2</b>	<b>0.2</b>	<b>0.2</b>	<b>0.2</b>	<b>sec</b>

2.4.3. The post-accident service report indicates that the porosity of the glider failed due to the 17.7 seconds porosity reading on the top right surface of the wing. **However, comments received from the manufacturer indicate that the porosity is unlikely to be a significant contributing factor to the accident.**

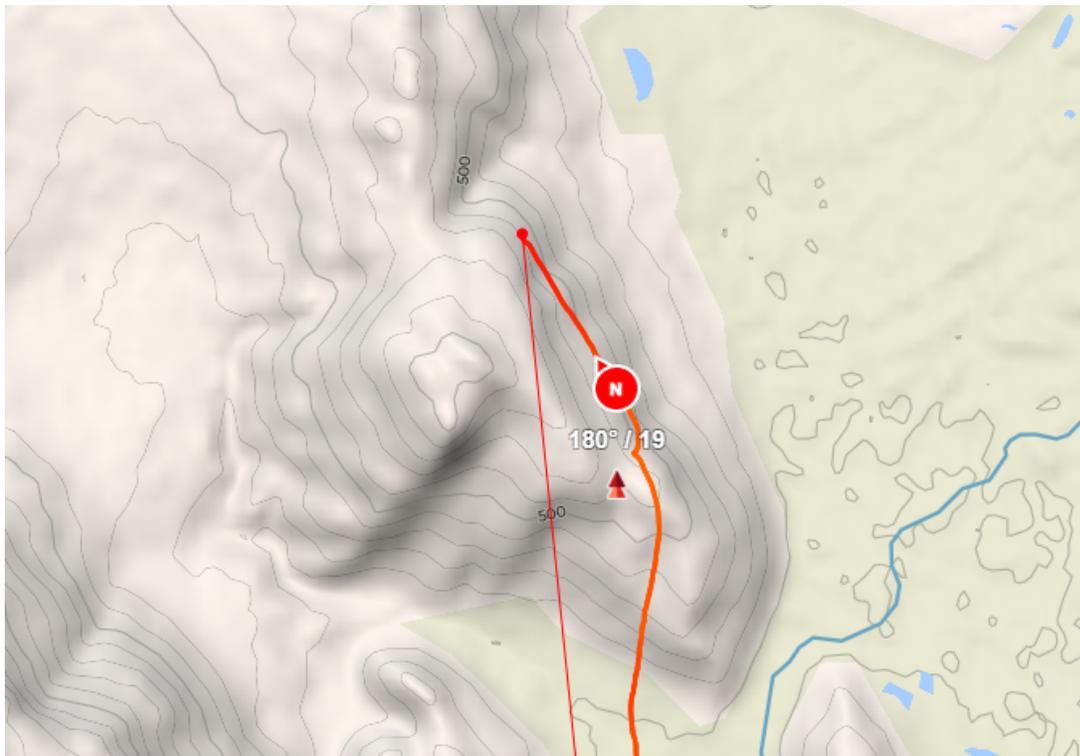
- 2.2.1. Analysis of the forecasts, the actuals from the Worcester AWS, witness statements and the GPS speeds from the pilot all point to strong wind at the accident location.
- 2.2.2. Wind direction forecast for the area of the accident, as well as that derived from the pilot's flight app on his mobile device, indicate a southerly wind direction (180 deg, 19 kph)

**Figure 28:** Screenshot of tracklog showing topography and wind calculations derived from the IGC tracklog (analysed using SeeYou software). Map orientation north facing up.

Analysing the wind speed, direction and topography of the terrain it is **quite likely that the main cause of the accident was the rotor (mechanical turbulence)** created from the southern end of the mountain flowing down the northeast-facing ridge on which the accident occurred.

4.3.1. It is recommended that SAHPA remind pilots of the dangers of flying in strong wind. These dangers include both the immediate danger of rotor turbulence, as well as possible delays of medical assistance due to inclement weather hindering rescue efforts, especially in difficult-to-access terrain.
