# Preliminary Accident Report

Version number: 1.1

Date 29 July 2023

**Reference Number:** SAHPA/103/04/04/2023

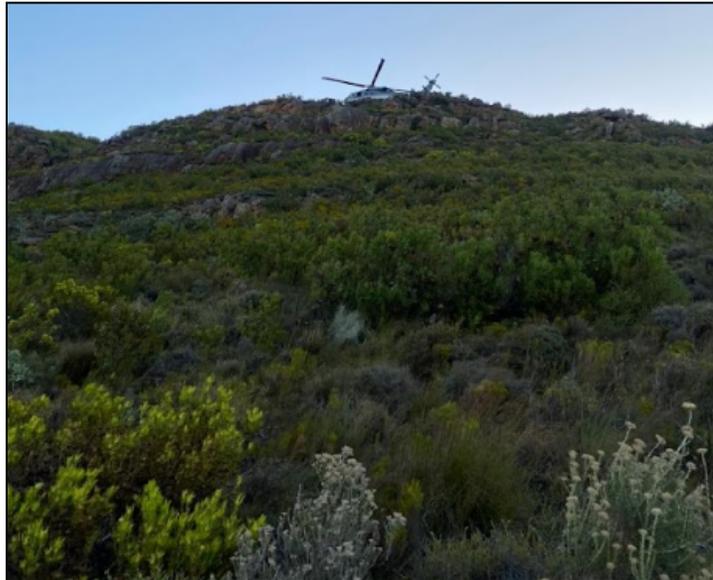
- 1.1.11. The location of the accident site is on the east-facing ridge of the mountain to the west of the town of Wolseley. The terrain is rocky and covered in fynbos. The crash site is approximately 300m higher than the farmland below.

**Figure 3:** Photo from the accident scene showing terrain with the rescue helicopter at the top

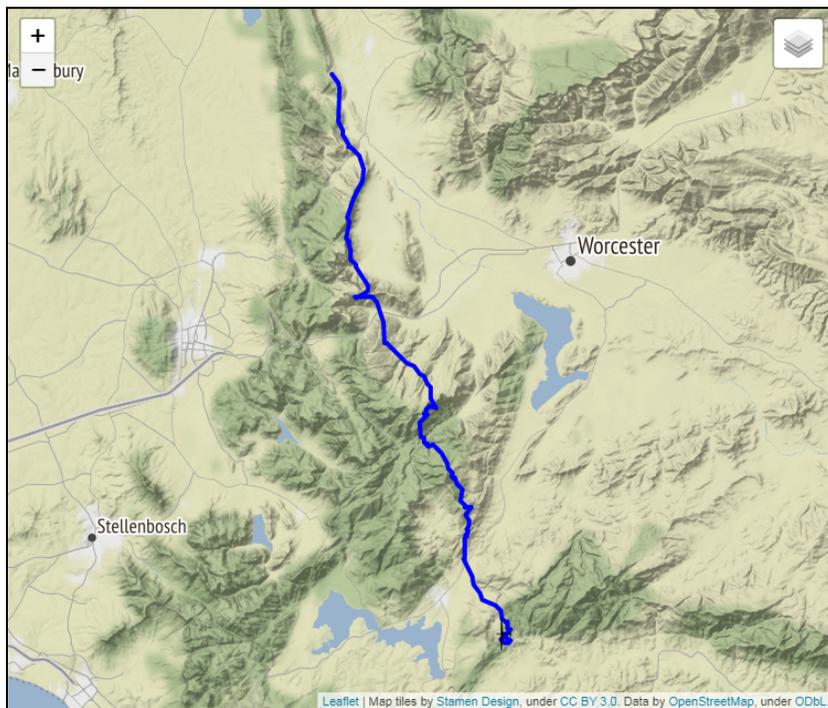
**Figure 14:** Overall flight path derived from the available tracklog. Map orientation north facing up.

1.10.1.2. 2D View showing the last section of the flight. At 14:40:39 a GPS Speed of 89kph was recorded at 14h40 i.e. two minutes before the accident. It also shows that the pilot flew on NNW heading following the contour of the ridge. **The accident occurred on the downwind side of the ridge if the wind was coming from the south.**

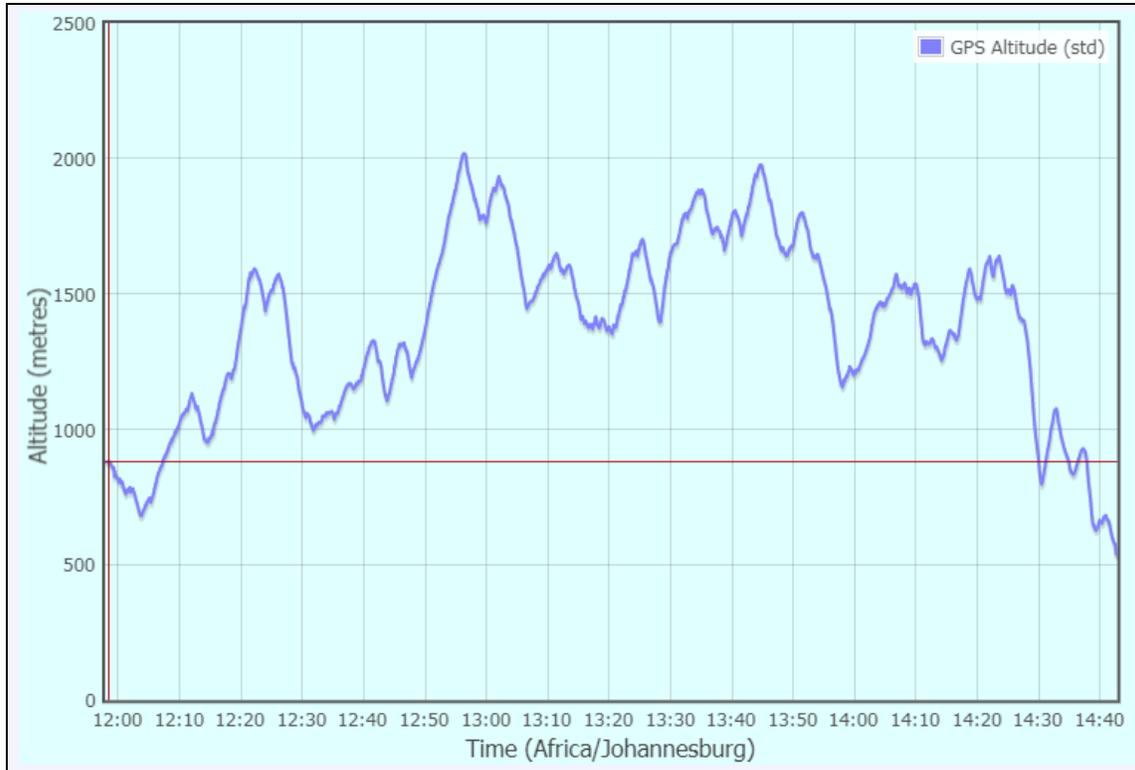
**Figure 15:** Flight altitudes over the duration of the flight

1.10.1.5. Analysis of GPS altitude for the last 10 seconds of flight. The typical descent rate of a paraglider is 1m/s in still air. Paragliding rescue parachutes are tested to withstand landings of 5.5m/s. In the last 3 seconds before coming to a stop, the glider descended from an altitude of 567m to 541m. This equates to a drop of 26m over 3 seconds or an average descent of 8.7m/s. This is a **significantly high descent rate**. It also implies that the **pilot was relatively close to the terrain** when an occurrence caused the rapid loss of height which resulted in the accident.

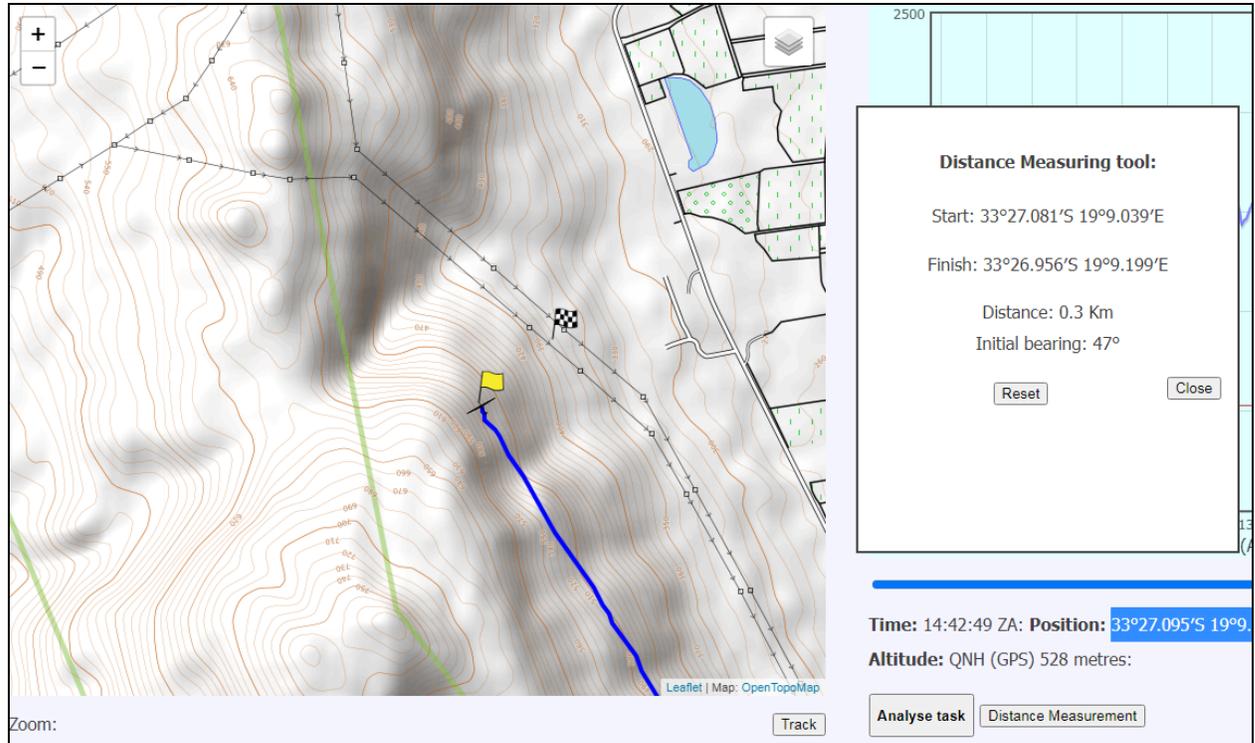
- 1.11.1. Location of the accident: 33°27.095'S 19°9.047'E
- 1.11.2. The terrain is mountainous and covered in fynbos with no easy access
- 1.11.3. Located west of farmhouses below
- 1.11.4. Witness statements indicate that the pilot was found lying unconscious on his left side with his head higher than his feet, facing in a northerly direction. There were no signs of bleeding and no broken bushes in the area.
- 1.11.5. Power lines in the vicinity, 300m away from the accident site at its closest point

**Figure 21: Accident location including power-line proximity (300m between flags diagram). Map orientation with north facing up.**
